REPORT NO. 3543

THE PENNSYLVANIA RAILROAD COMPANY

IN RE ACCIDENT

Accident at Philadelphia, Pa., on November 11, 1953, caused by failure to operate a train in accordance with a signal indication when the route for the train was being lined, resulting in movement of a power-operated switch under the train.

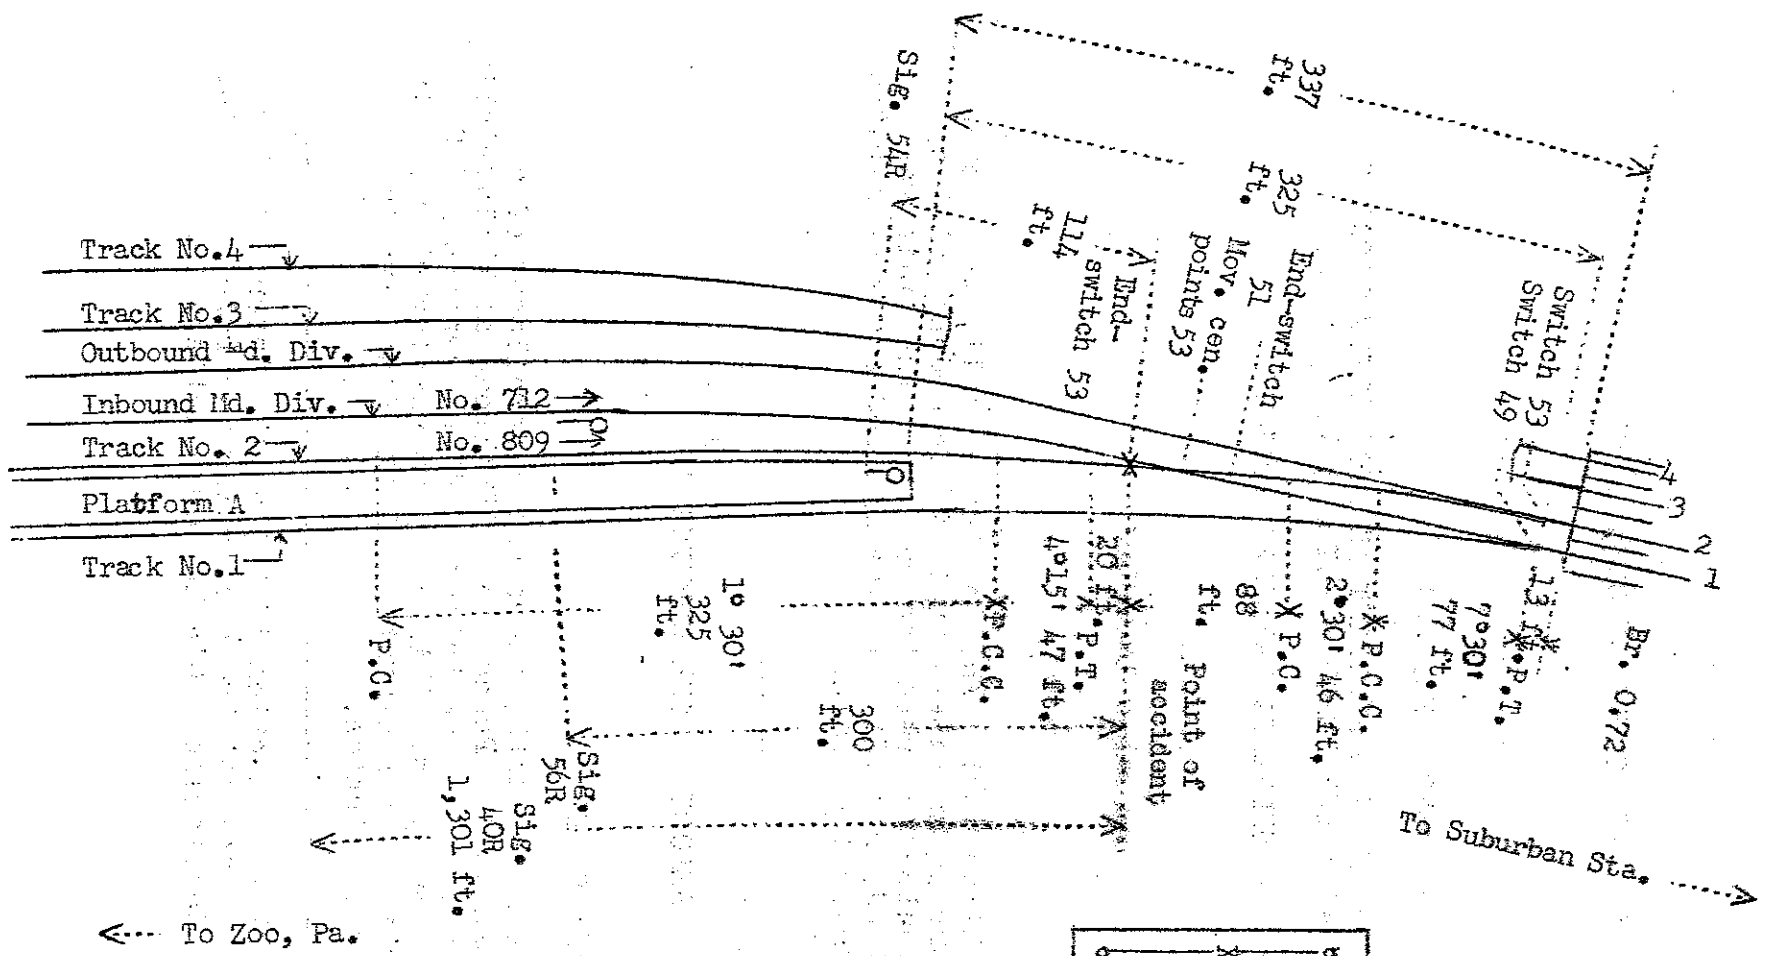
Report No. 3543
 Pennsylvania Railroad
 Philadelphia, Pa.
 November 11, 1953

and the rear truck of the first car, both trucks of the second to fourth cars, inclusive, and the front truck of the fifth car were diverted toward track No. 1 at slip switch 53-51. The train stopped before the rear truck of the fifth car reached this switch. The side of the first car struck the girder of Bridge 0.72 between Nos. 1 and 2 tracks. This car was derailed and stopped on the bridge with the center of the car on the top of the girder. A separation occurred between the first and second cars. The second car was derailed and stopped approximately in line with track No. 1. None of the other cars of the train was derailed. The first and second cars were badly damaged.

After the accident occurred it was found that lever 54 was in position for signal 54R to display a stop indication, levers 49 and 53 were in normal position, and lever 51 was in reverse position. When lever 53 is in normal position end-switch 53 is lined for movement from track No. 2 to track No. 1. Examination of the track structure disclosed that the positions of the switches corresponded to the positions of the levers. No marks were found to indicate that any of the equipment was derailed at the slip switch. The first marks of derailment were found in the vicinity of switches 49 and 53.

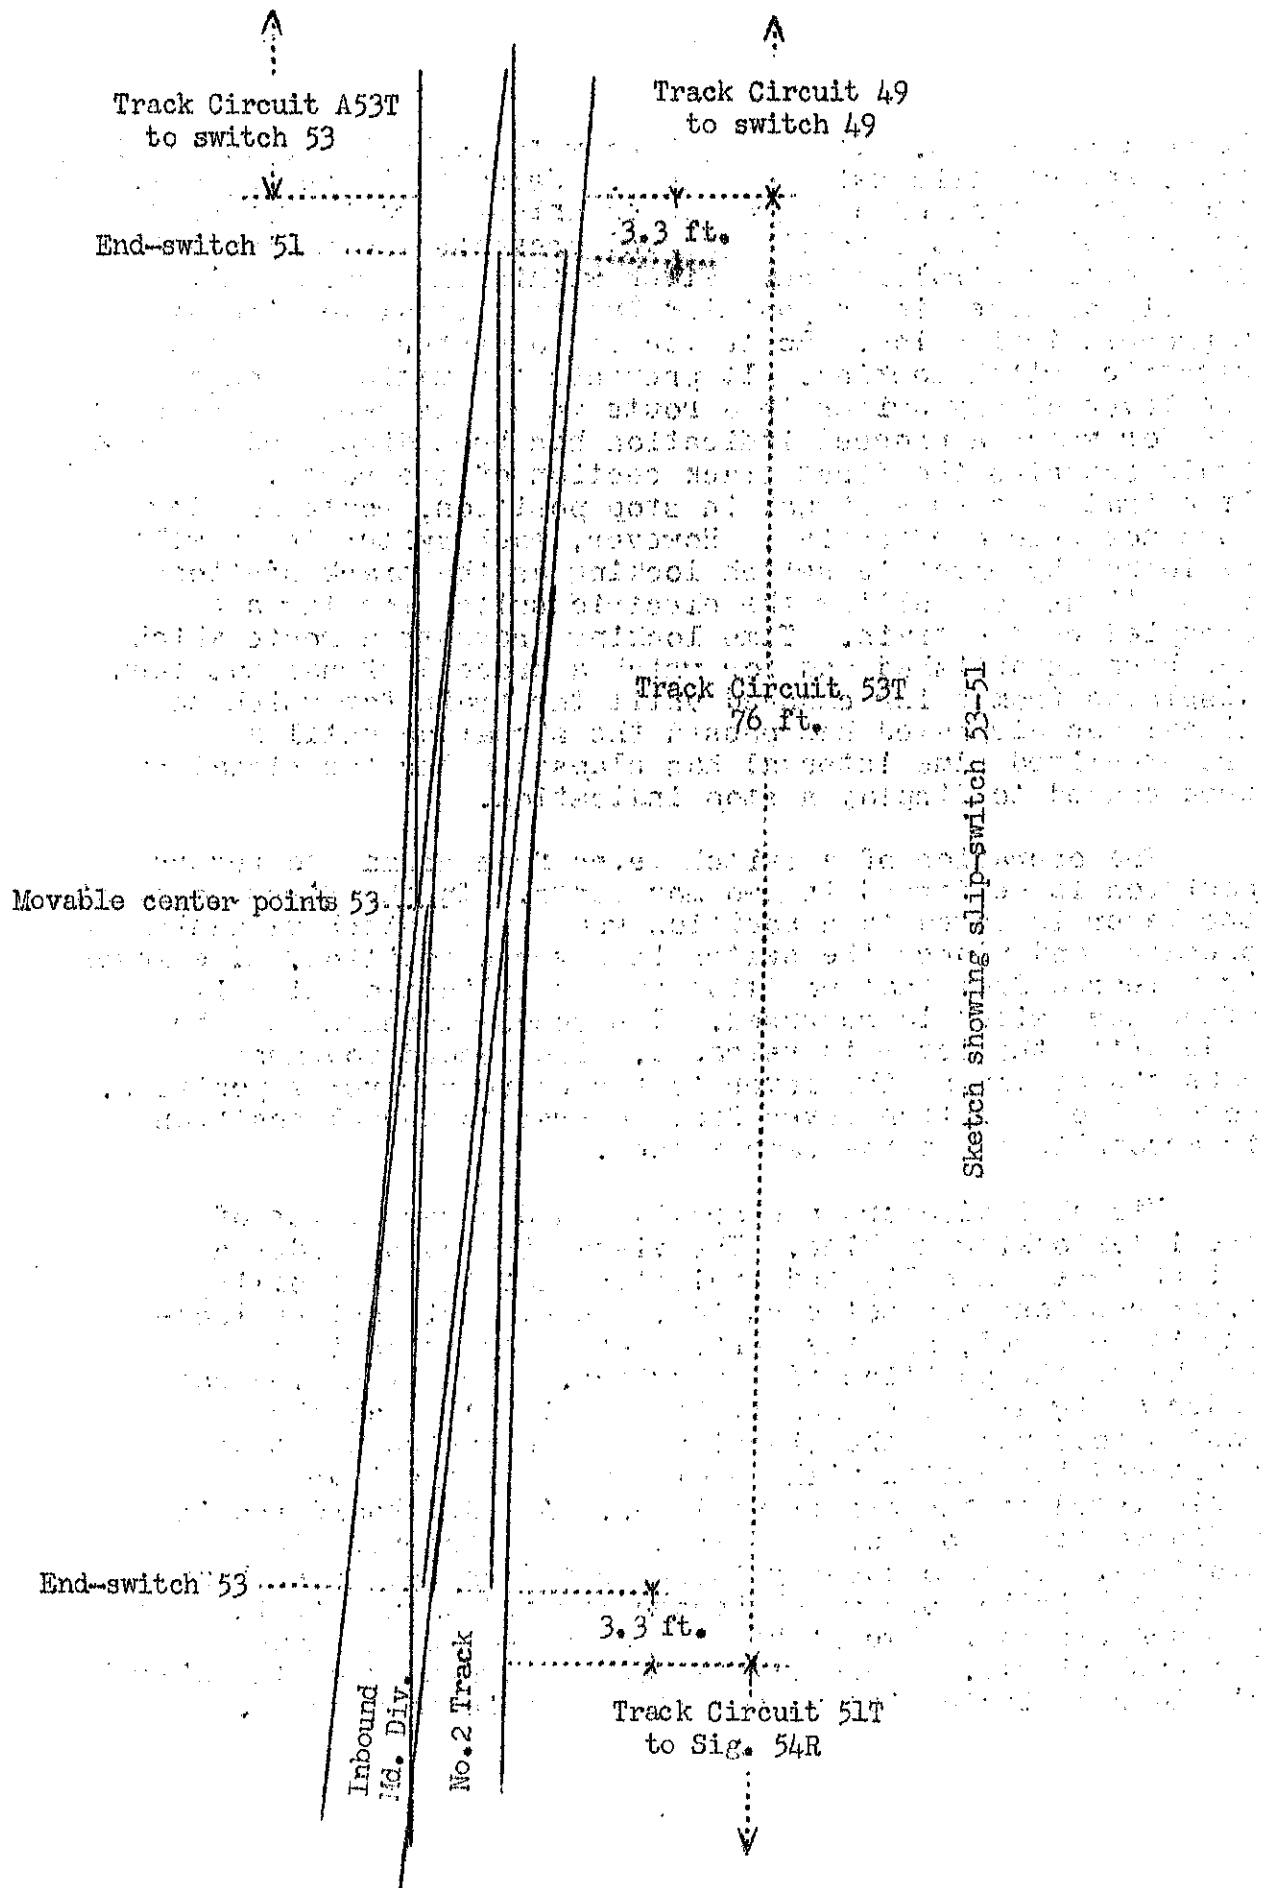
Lever 53 controls the operation of end-switch 53, the movable center points of slip switch 53-51, and switch 53. Levers 49 and 51 control the operation of switch 49 and end-switch 51. Track circuit 51T, controlling the electric switch locking of lever 51, extends between a point approximately opposite signal 54R and a point 3.3 feet west of end-switch 53. Track circuit 53T, controlling the electric switch locking of levers 51 and 53, extends 76 feet east of the east end of circuit 51T through slip switch 53-51. Track circuit 49 extends eastward from the east end of circuit 53T through switch 49, and track circuit A53T extends eastward from the east end of circuit 53T through switch 53.

moved after the front truck of the first car passed over it. Electric switch locking is ineffective for lever 53 if a train passes signal 54R when that signal indicates Stop and when lever 53 is not in extreme normal or reverse position. As a result of this investigation it is apparent that signal 54R indicated Stop when No. 809 passed that signal; that before No. 809 occupied track circuit 53T, the leverman, who was engaged in lining the route, moved lever 53 to the position where the switches controlled by that lever were in reverse position but electric switch locking was not effective; and that he returned the lever to normal position after the wheels of the first truck of the first car of No. 809 passed end-switch 53.
